Intel® Pentium® 4 Processor

Specification Update

November 2003

Document Number: 249199-044

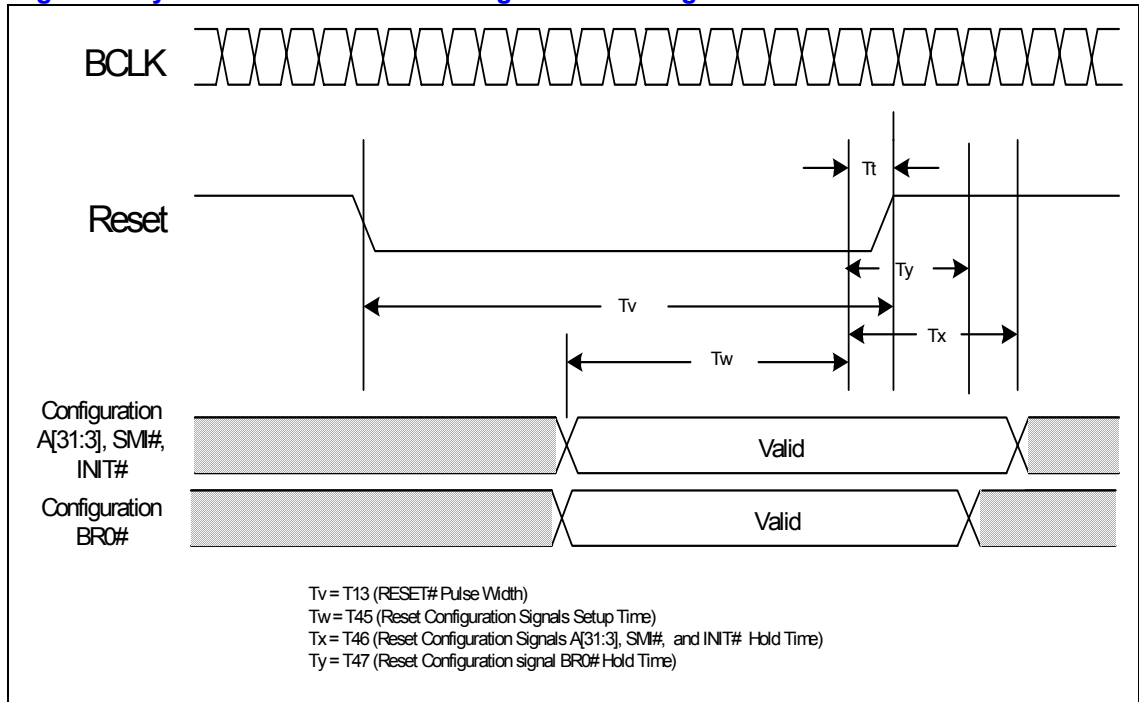
Figure System Bus Reset and Configuration Timings

The following figure will be modified to reflect this change:
